Annual Inspection Report		Page No. 1 of 1	
<i>Inspection and report meeting the requirements of Part 257.84(b)</i>			
Merrimack Station Ash Landfill	Location: Bow, New Hampshire	Year: 2024	File No. 2025.15
Date of Inspection:	October 10, 2024	Volume of CCR in place:	213,300 cubic yards
Completed by:	Harrison R. Roakes, PE		
Changes in landfill geometry since previous annual inspection? Yes <input type="checkbox"/> No <input checked="" type="checkbox"/> <i>If yes, please explain below.</i>			
Observed actual/ potential structural weakness? Yes <input type="checkbox"/> No <input checked="" type="checkbox"/> <i>If yes, please explain below.</i>			
Observed existing conditions that are disrupting/could disrupt the operation and safety of the facility? Yes <input type="checkbox"/> No <input checked="" type="checkbox"/> <i>If yes, please explain below.</i>			
Other Observations:			
<ul style="list-style-type: none"> • Material was added to the active face of the landfill by constructing benches. There was some erosion of benched materials on the active face, and the eroded material washed into the existing lined cell that includes leachate collection. Placement of additional material sho

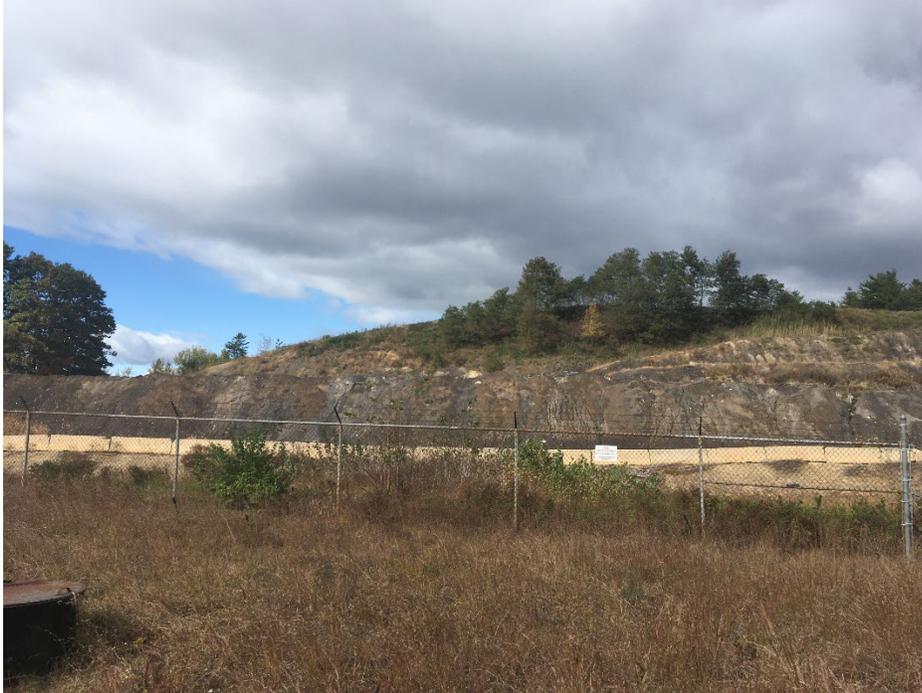
Photo 1: Landfill working face in the background and perimeter fence near leachate collection tanks in foreground. The photograph was taken looking north.

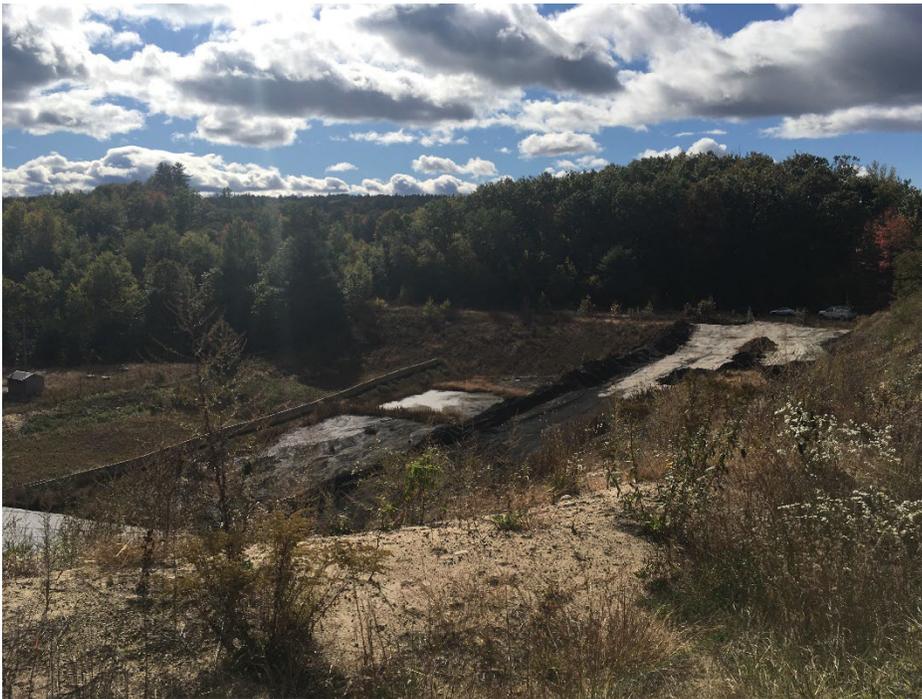
Photo 2: Landfill working face with benched slope constructed. The photograph was taken from near the top of the active cell and looking west.

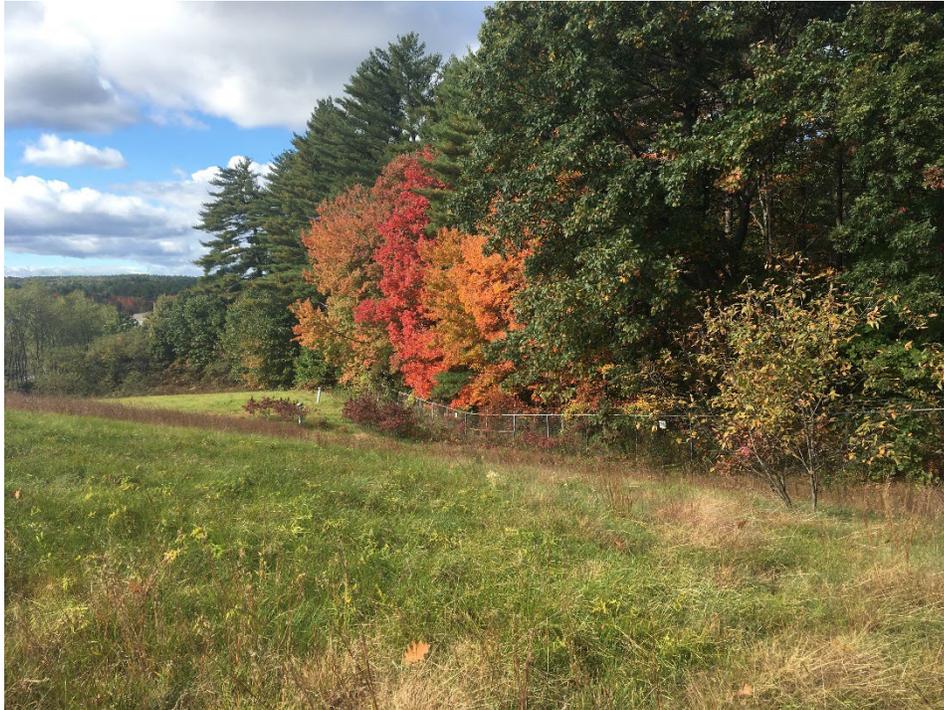
Photo 3: Stable and established slopes in inactive, capped area of landfill. The photograph was taken from near the top of the filled area and looking north.

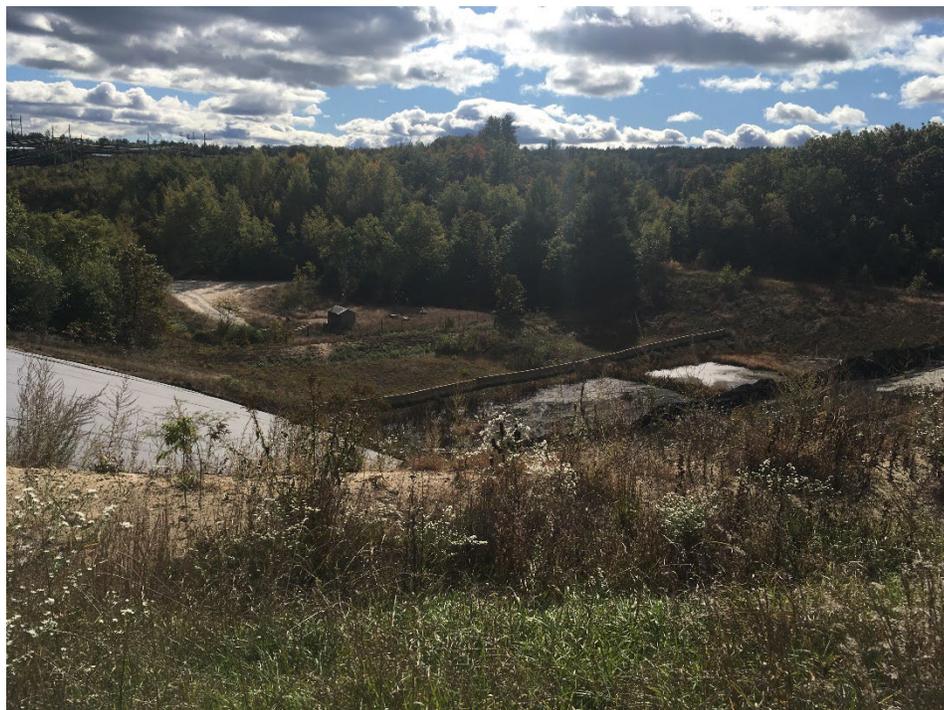
Photo 4: Landfill area not currently being filled (grassy area between leachate collection building and concrete barriers). The liner is visible on the left side of the photograph. The photograph was taken from near the top of the active cell and looking southwest.
