Annual Inspection Report

Merrimack Station Ash Landfill

Location: Bow, New Hampshire

Year: 2015

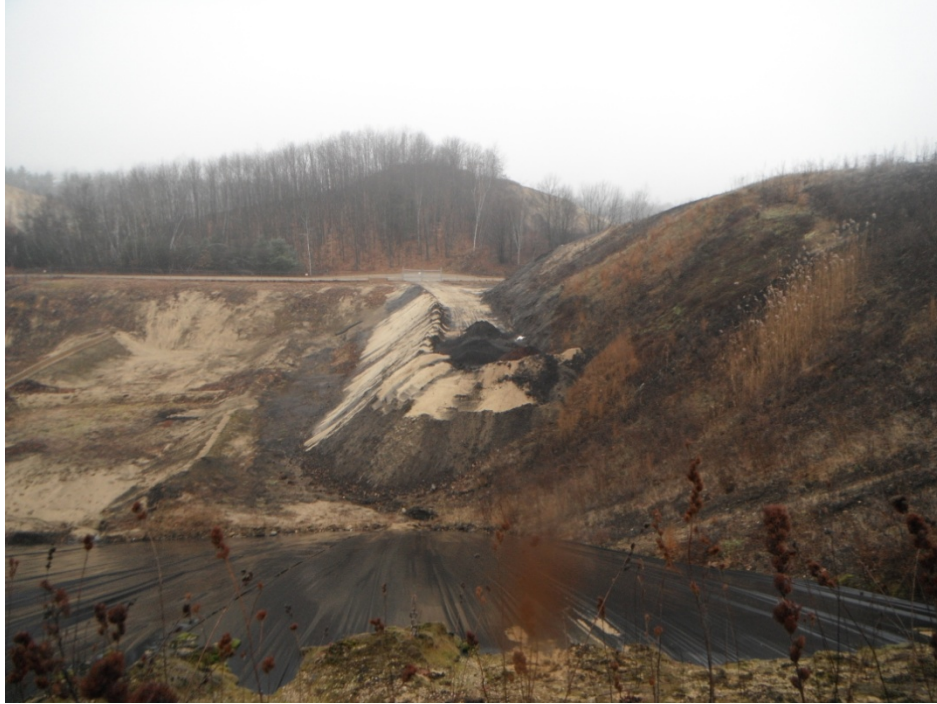
Photo 1: Active cell of the landfill with steep slope at working face.

- Steep slope observed at the active face of the landfill. If the slope failed, CCR would slide into existing empty lined cell. We recommend reducing the slope for safety of operators.
- Limited woody vegetation observed growing near the location of the anchor trench. We recommend removing the vegetation. Vegetation has been noted on the weekly inspection forms and work is in progress.
- Larger rocks were observed on the liner at the bottom of the empty cell. Based on review of the weekly inspection forms, the rocks were removed on 12/18/2015 by site personnel
- The leachate collection and storage system was observed to be in good operating condition.
- Perimeter fence was secure and in good condition.
- Vegetation is established in inactive areas of the landfill.
- Limited erosion was observed near the active face of the landfill. Re-grading of the area is recommended.

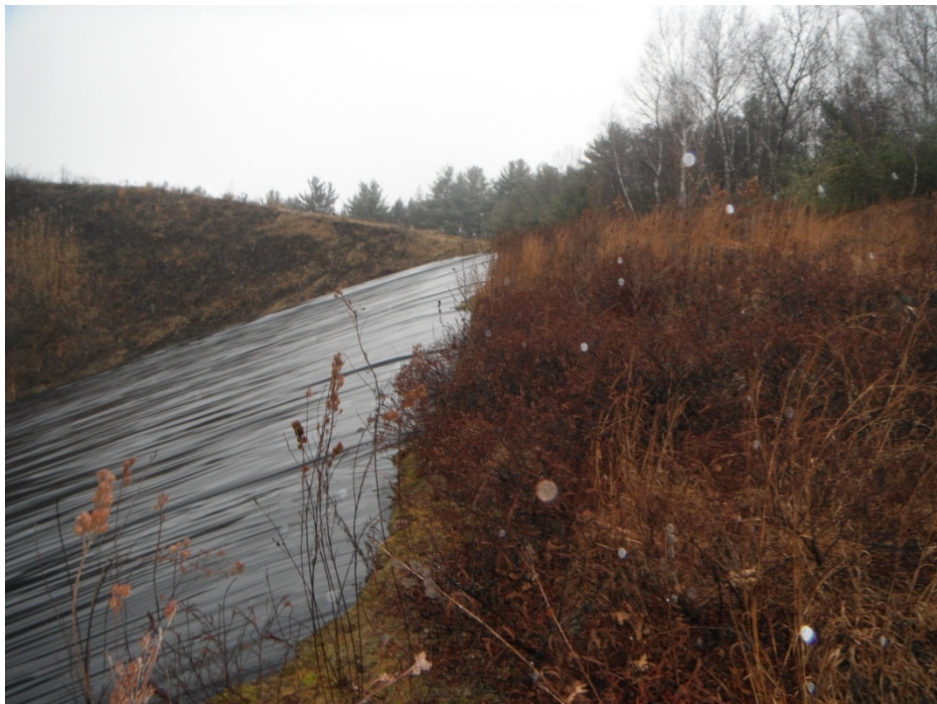
Photo 2: Limited woody vegetation growing near anchor trench.

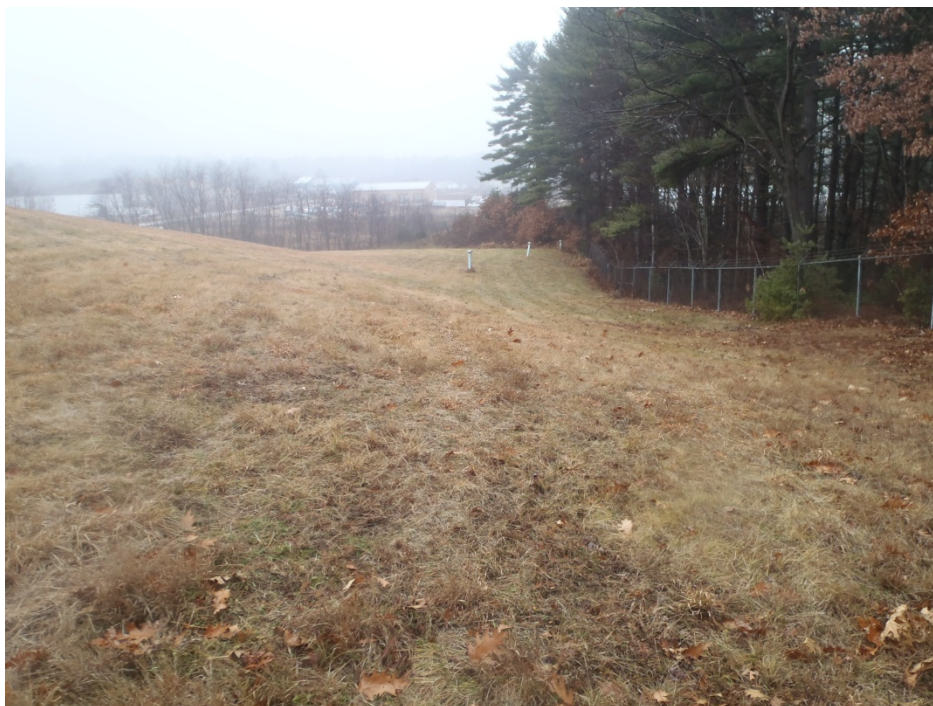
Photo 3: Established vegetation in inactive area of landfill

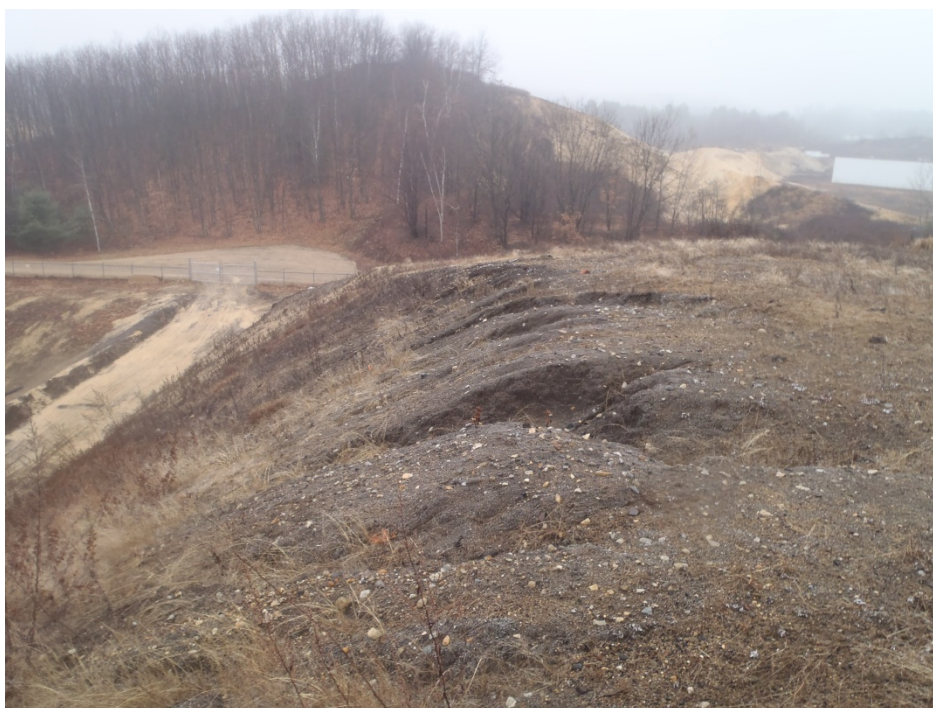
Photo 4: Limited erosion near active face of the landfill.
