# Annual Inspection Report

Merrimack Station Ash Landfill

Location: Bow, New Hampshire

**Date of Inspection:** January 4, 2017 Volume of CCR in place: 203,000 cubic yards

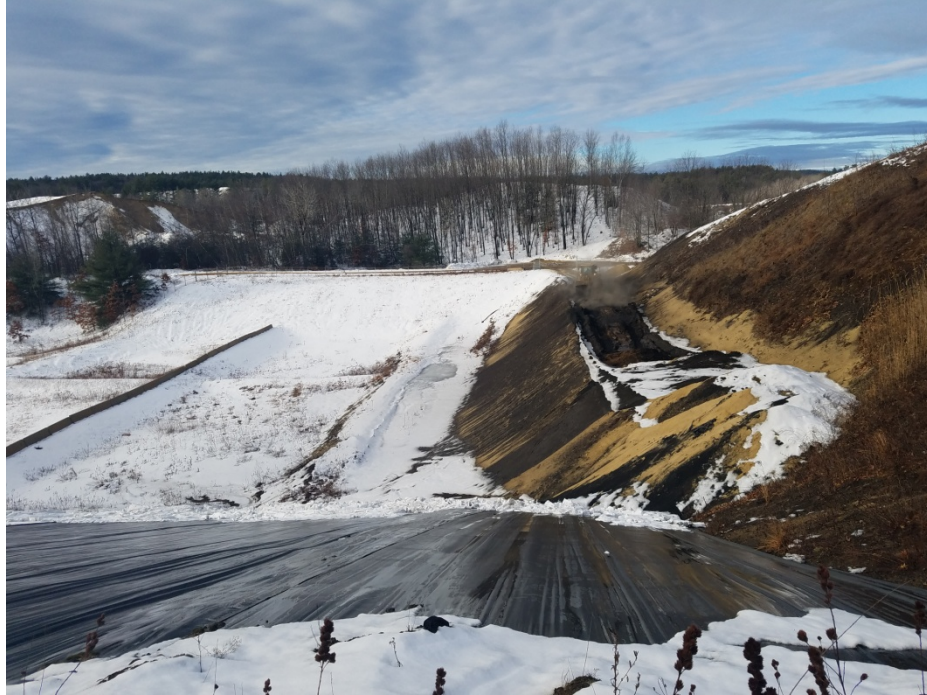
*Steep slope observed at the active face of the landfill. Sanborn Head performed an Interim Slope Stability Evaluation, dated 2/29/2016 and concluded that the slope was likely stable for interim conditions. However, to reduce the potential for instability, we recommended that the slope be flattened such that the inclination approaches 2H:1V or flatter. The slope modification has not been completed at this time.*

Photo 1: Active cell of the landfill with steep slope at working face.

- Steep slope observed at the active face of the landfill. If the slope failed, CCR would slide into existing empty lined cell. We recommend reducing the slope for safety of operators.
- Limited woody vegetation observed growing near the location of the anchor trench. We recommend removing the vegetation.
- The leachate collection and storage system was observed to be in good operating condition.
- Perimeter fence was secure and in good condition.

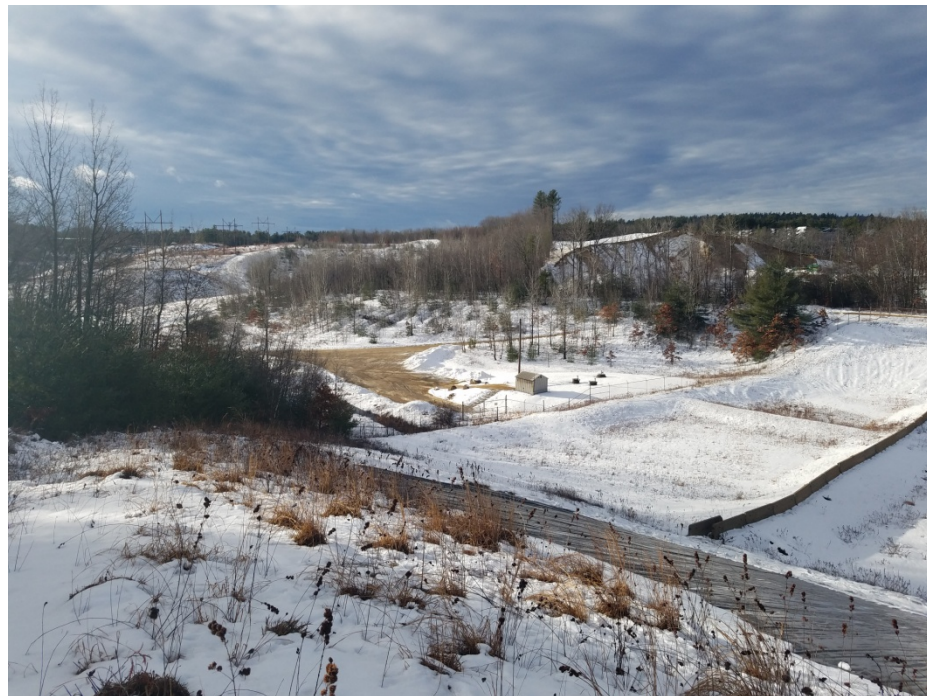
*Limited woody vegetation observed growing near the location of the anchor trench. Vegetation was removed during January 2016; however, there is now additional growth that we recommend removing.*

Photo 2: Limited woody vegetation growing near anchor trench.

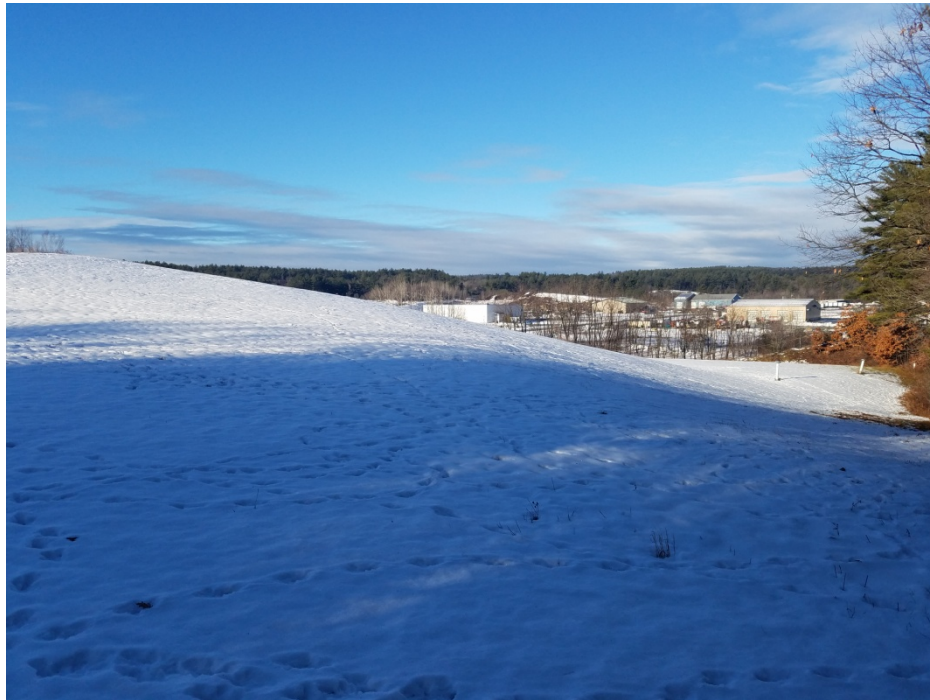
Photo 3: Stable and established slopes in inactive capped area of landfill.

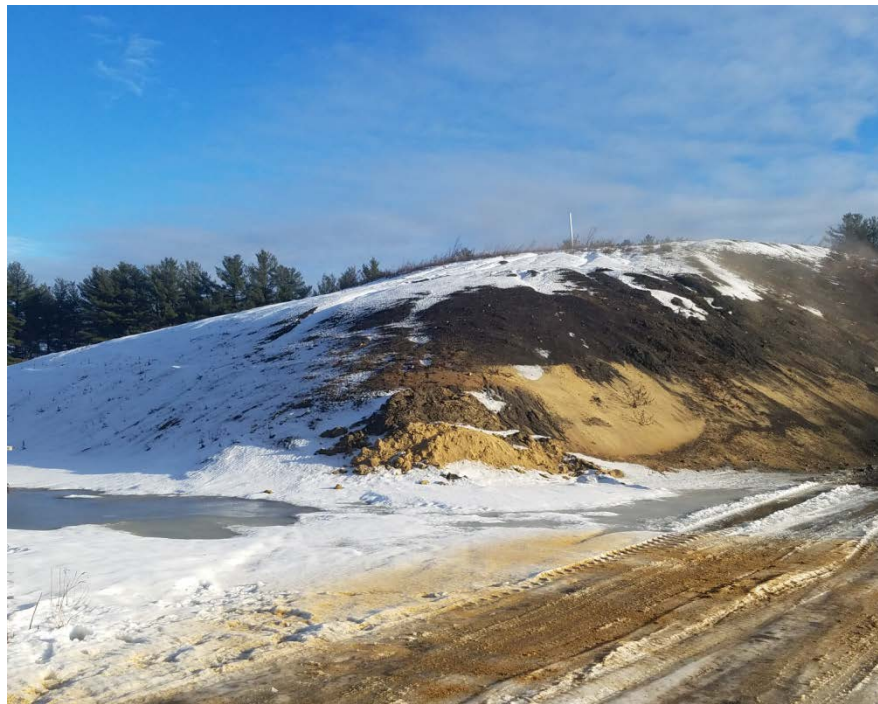
*Limited erosion was observed near the active face of the landfill during the 2015 Annual Inspection and re-grading of the area was completed in 2016.*

Photo 4: Area where limited erosion near active face of the landfill was repaired in 2016.
