Annual Inspection Report		Page No. 1 of 1	
<i>Inspection and report meeting the requirements of Part 257.84(b)</i>			
Merrimack Station Ash Landfill	Location: Bow, New Hampshire	Year: 2017	File No. 2025.06
Date of Inspection:	January 8, 2018	Volume of CCR in place: 204,000 cubic yards	
Completed by:	Lisa Damiano, P.E.		
Changes in landfill geometry since previous annual inspection? Yes <input type="checkbox"/> No <input checked="" type="checkbox"/> <i>If yes, please explain below.</i>			
Observed actual/ potential structural weakness? Yes <input type="checkbox"/> No <input checked="" type="checkbox"/> <i>If yes, please explain below.</i>			
Observed existing conditions that are disrupting/could disrupt the operation and safety of the facility? Yes <input type="checkbox"/> No <input checked="" type="checkbox"/> <i>If yes, please explain below.</i>			
Other Observations:			
<ul style="list-style-type: none"> • Steep slope observed at the active face of the landfill. If the slope failed, CCR would slide into existing empty lined cell. We recommend reducing the slope for safety of operators. • The leachate collection and storage system was observed to be in good operating condition. •

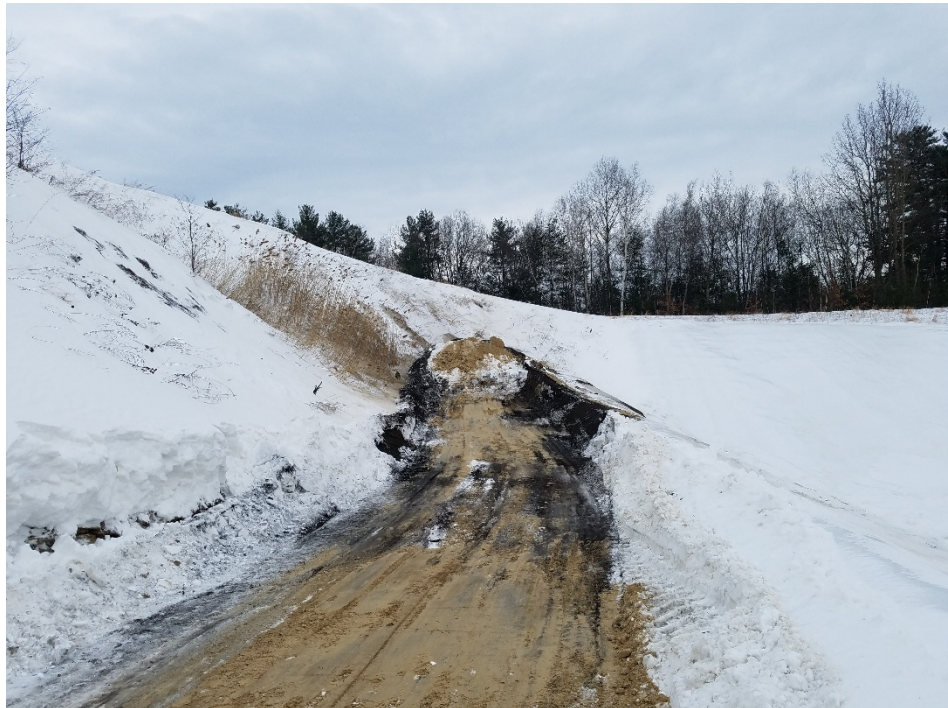
Photo 1: Active cell of the landfill with steep slope at working face.

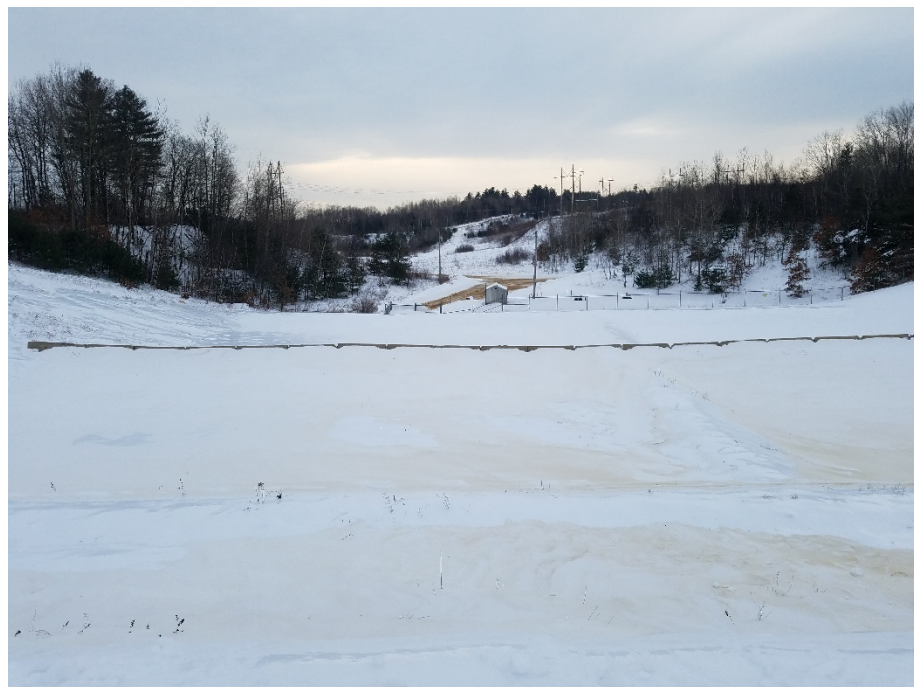
Photo 3: Stable and established slopes in inactive capped area of landfill.
