Annual Inspection Report		Page No. 1 of 1	
<i>Inspection and report meeting the requirements of Part 257.84(b)</i>			
Merrimack Station Ash Landfill	Location: Bow, New Hampshire	Year: 2018	File No. 2025.07
Date of Inspection:	December 7, 2018	Volume of CCR in place: 205,500 cubic yards	
Completed by:	Lisa Damiano, P.E.		
Changes in landfill geometry since previous annual inspection? Yes <input type="checkbox"/> No <input checked="" type="checkbox"/> <i>If yes, please explain below.</i>			
Observed actual/ potential structural weakness? Yes <input type="checkbox"/> No <input checked="" type="checkbox"/> <i>If yes, please explain below.</i>			
Observed existing conditions that are disrupting/could disrupt the operation and safety of the facility? Yes <input type="checkbox"/> No <input checked="" type="checkbox"/> <i>If yes, please explain below.</i>			
Other Observations:			
<ul style="list-style-type: none"> • Steep slope observed at the active face of the landfill. If the slope failed, CCR would slide into existing empty lined cell. We recommend reducing the slope for safety of operators. • The leachate collection and storage system was observed to be in good operating condition. •

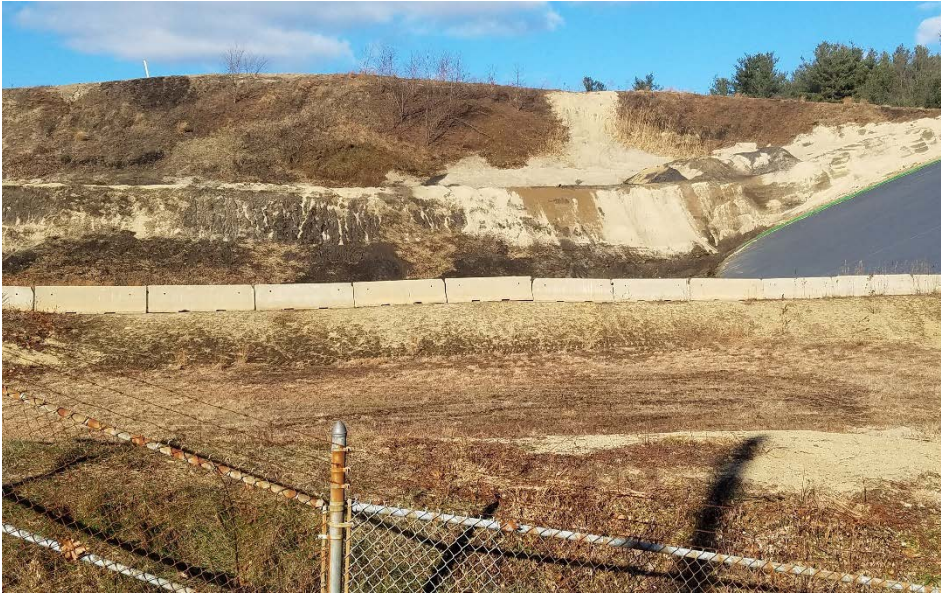
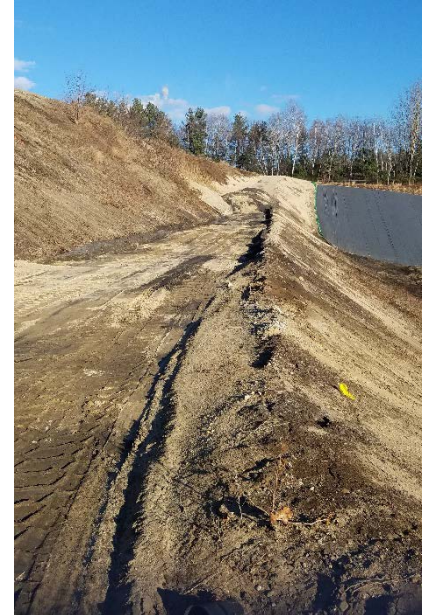
Looking North

Photo 1: Active cell of the landfill with steep slope at working face looking north (left photo) from leachate collection building and east from east side of active cell (right photo)

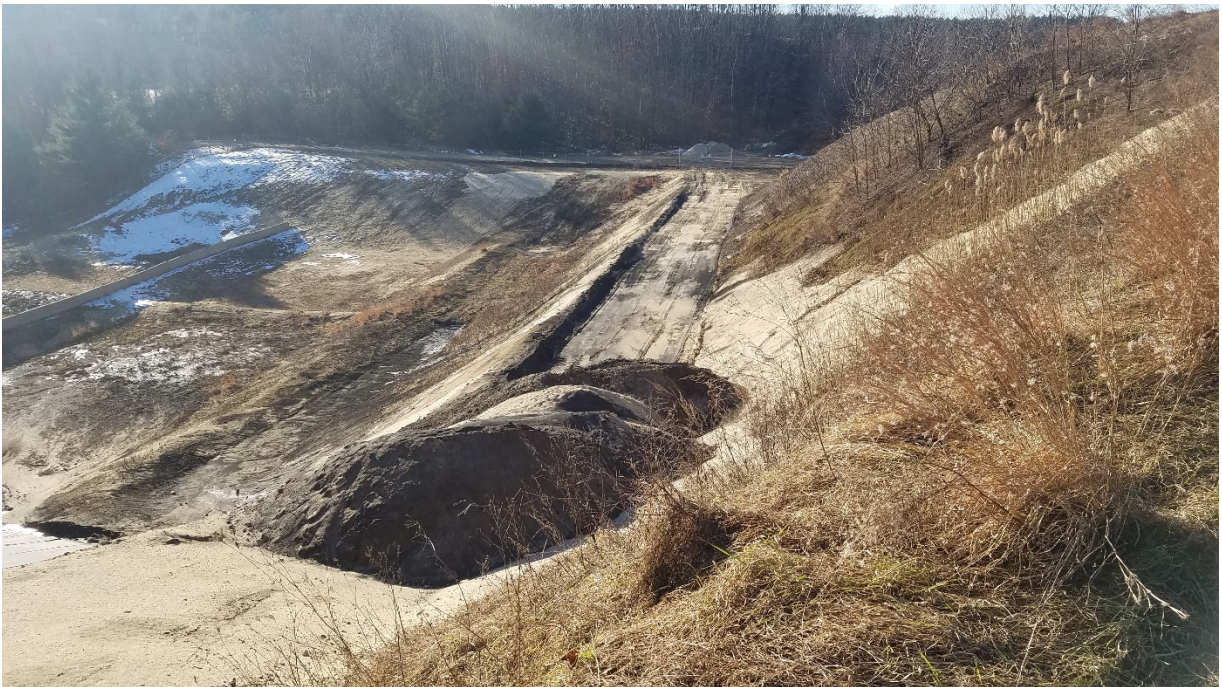
Photo 2: Active cell of the landfill with steep slope at working face looking west.

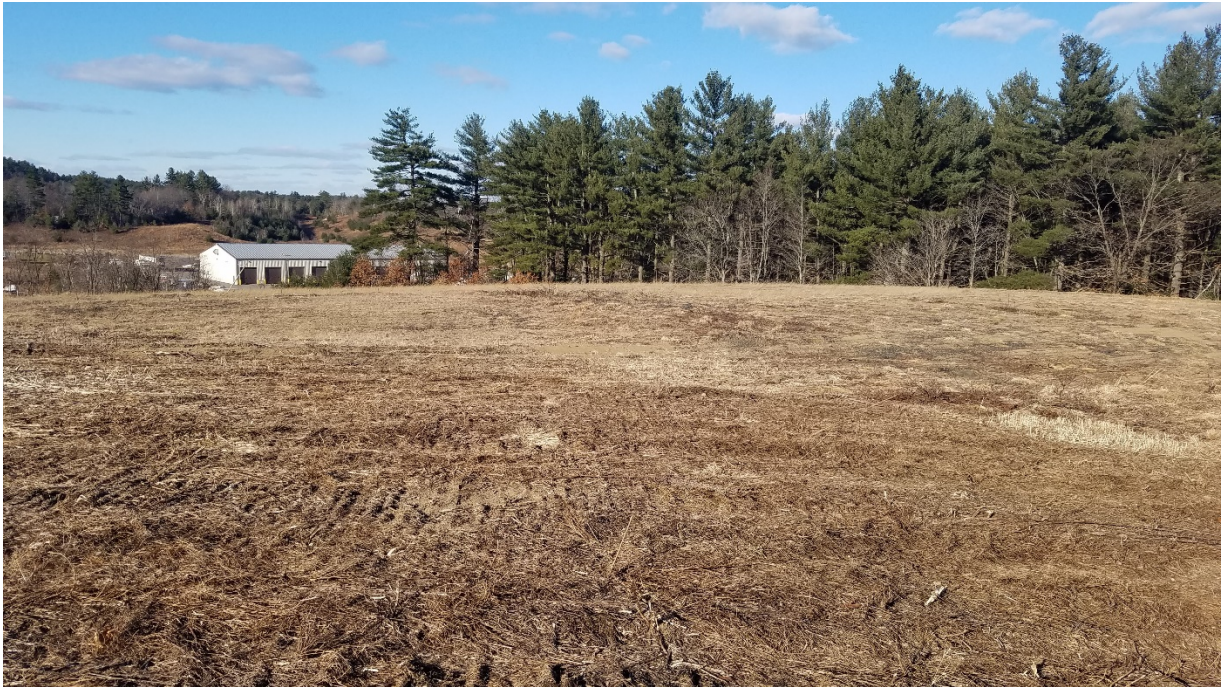
Photo 3: Stable and established slopes in inactive capped area of landfill looking north from top of active cell.

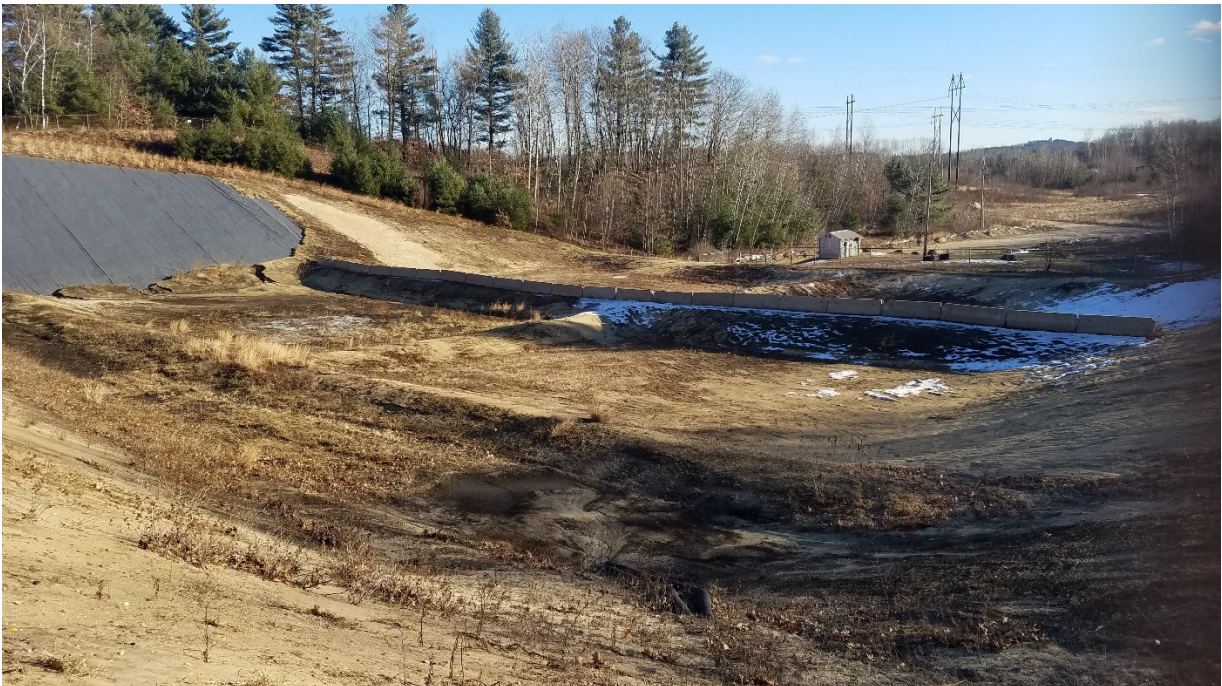
Photo 4: Landfill cells not currently in use looking southeast from east side of active cell.
