Annual Inspection Report

Inspection and report meeting the requirements of Part 257.84(b)

Merrimack Station Ash Landfill

Date of Inspection: October 3, 2019

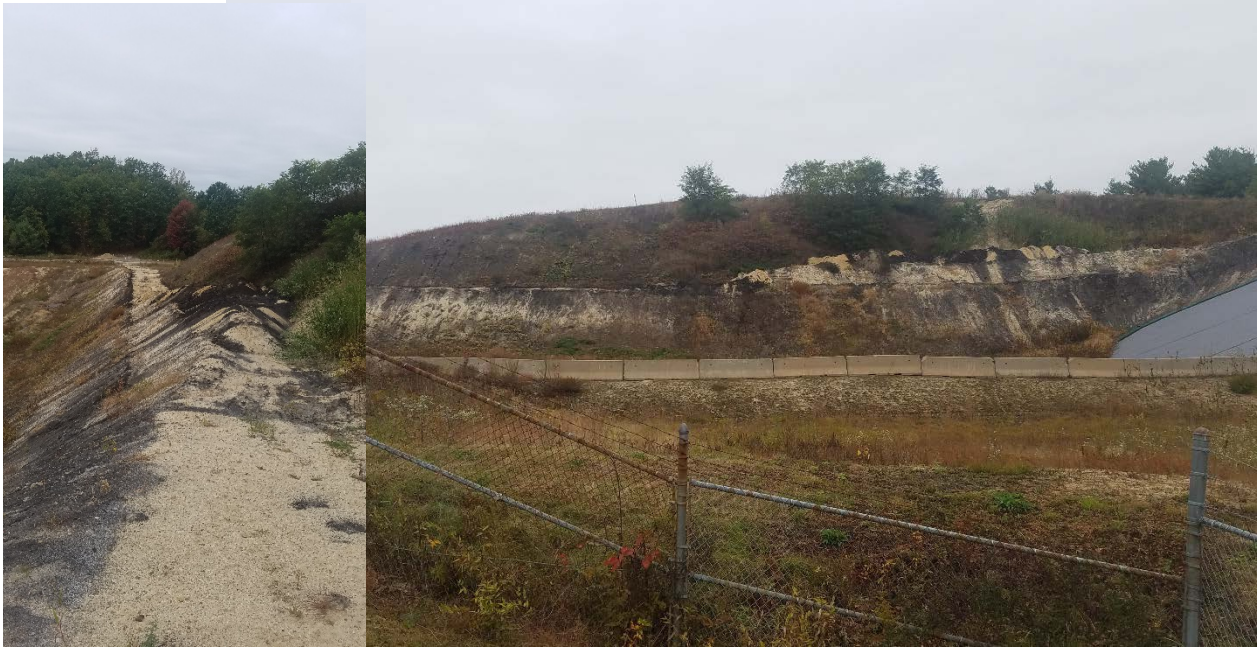
- Steep slope observed at the active face of the landfill. If the slope failed, CCR would slide into existing empty lined cell. We recommend reducing the slope for safety of operators.
- The leachate collection and storage system was observed to be in good operating condition.
- Perimeter fence was secure and in good condition.

Photo 1: Active cell of the landfill with steep slope at working face looking north (right photo) from leachate collection building and east from east side of active cell (left photo)

Steep slope observed at the active face of the landfill. Sanborn Head performed an Interim Slope Stability Evaluation, dated 2/29/2016 and concluded that the slope was likely stable for interim conditions. However, to reduce the potential for instability, we recommended that the slope be flattened such that the inclination approaches 2H:1V or flatter. The slope modification has not been completed at this time.

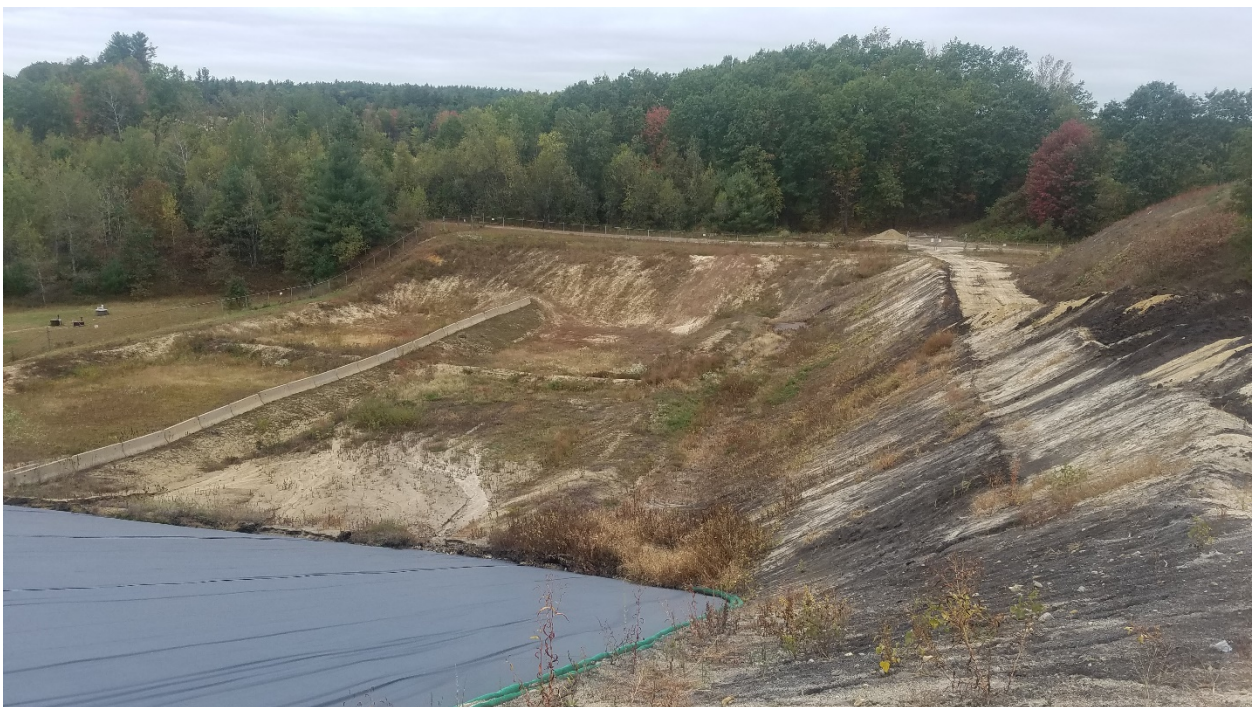
Photo 2: Active cell of the landfill with steep slope at working face looking west.

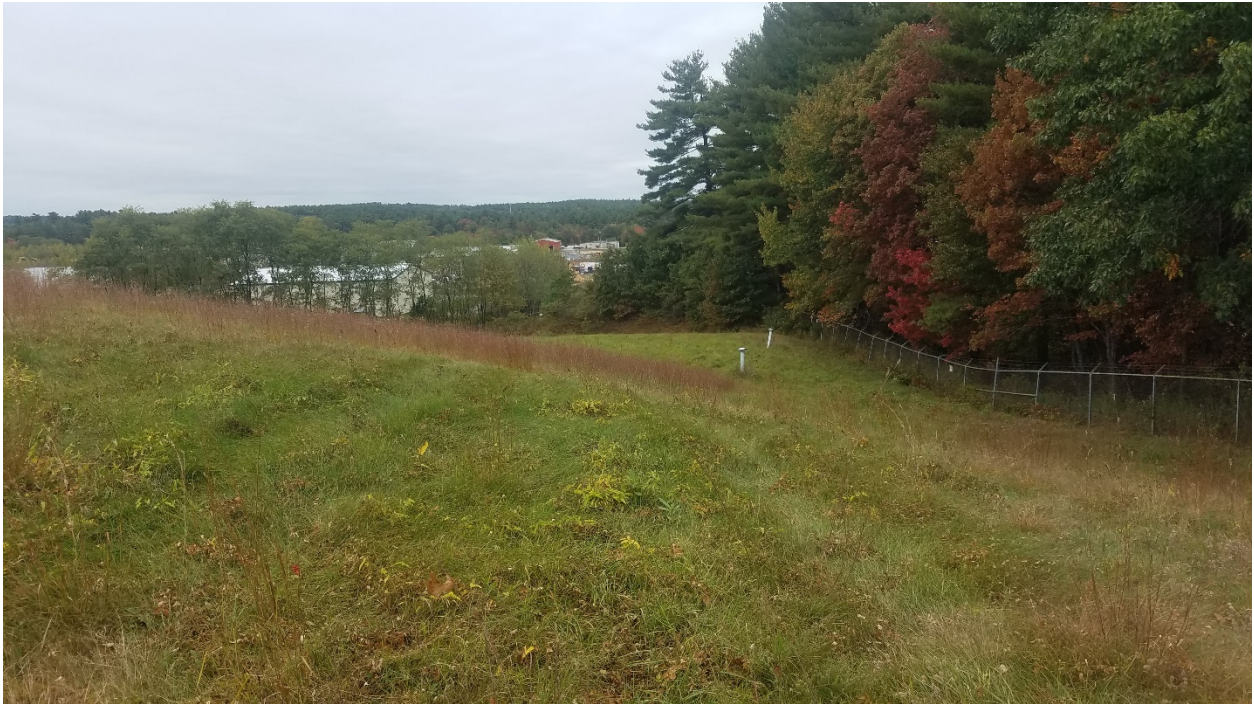
Photo 3: Stable and established slopes in inactive capped area of landfill looking north from top of active cell.

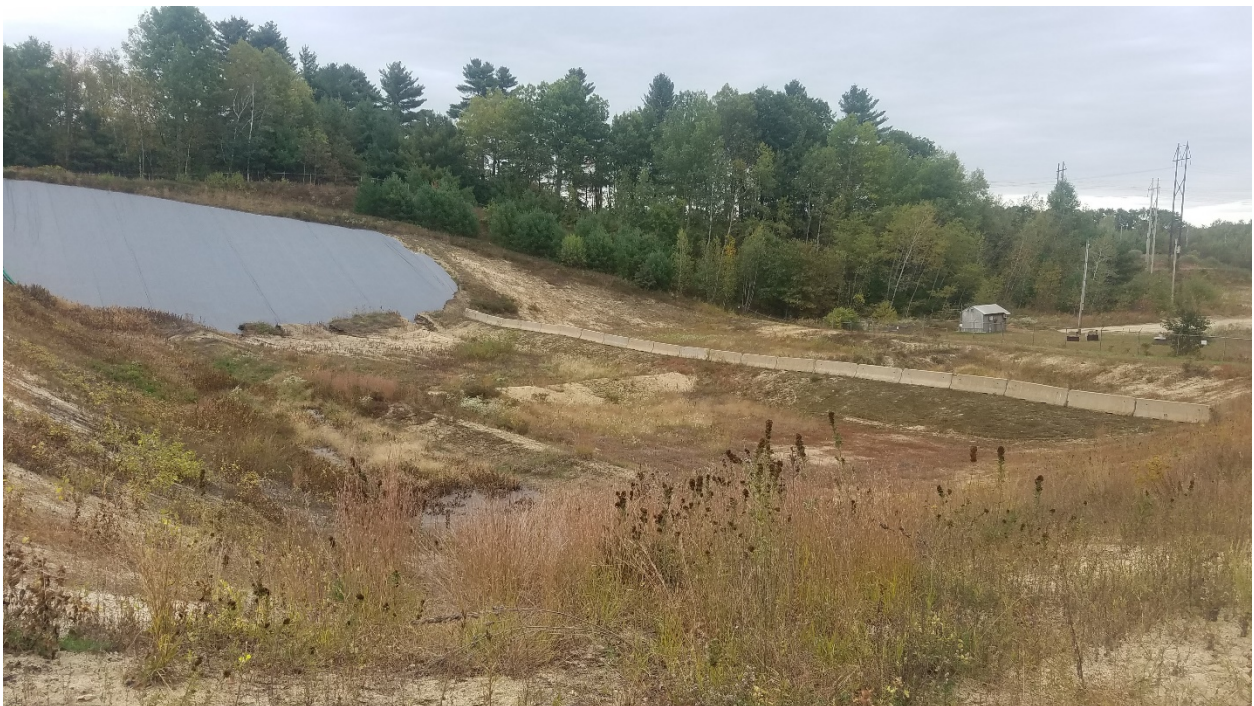
Photo 4: Landfill cells not currently in use looking southeast from east side of active cell.
