# Annual Inspection Report

*Inspection and report meeting the requirements of Part 257.84(b)*

Merrimack Station Ash Landfill

Year: 2021

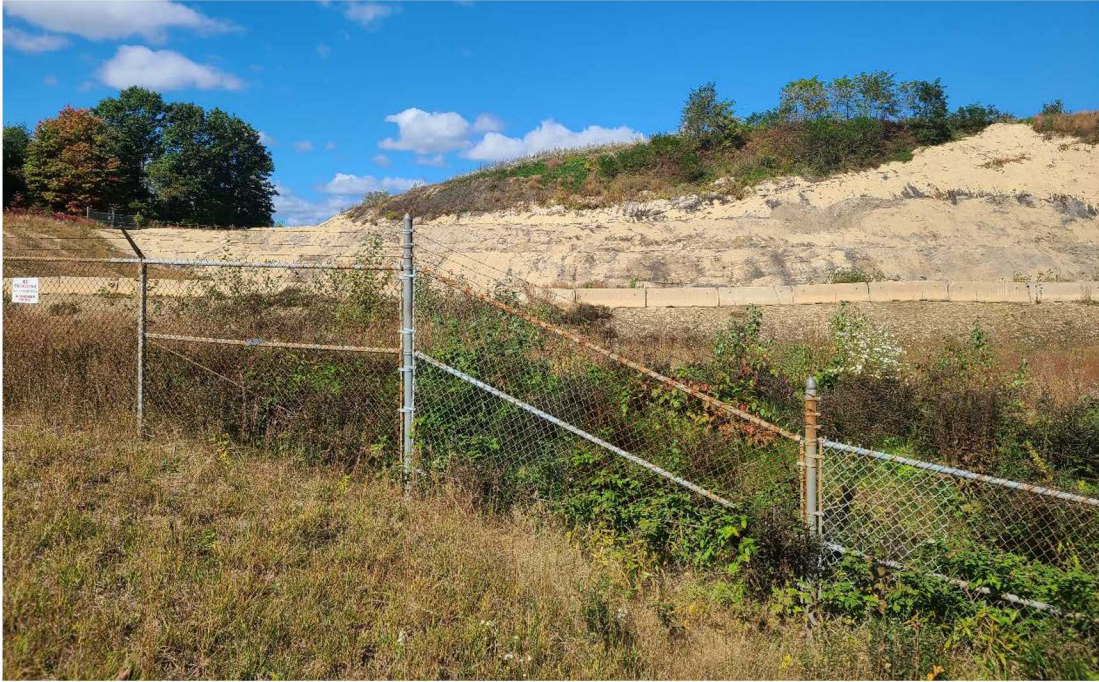
- The steep slope that was observed at the active face of the landfill was reduced. If the slope failed, CCR would slide into existing empty lined cell. We recommend continuing to reduce the slope for safety of operators.
- The leachate collection and storage system was observed to be in good operating condition.
- Perimeter fence was secure and in good condition.

*Steep slope observed at the active face of the landfill. Sanborn Head performed an Interim Slope Stability Evaluation, dated 2/29/2016 and concluded that the slope was likely stable for interim conditions. However, to reduce the potential for instability, we recommended that the slope continue to be flattened such that the inclination approaches 2H:1V or flatter. During 2020 and 2021, the slope has been reduced through benched filling operations.*

Photo 1: Active cell of the landfill with reduced steep slope at working face looking north from leachate collection building.

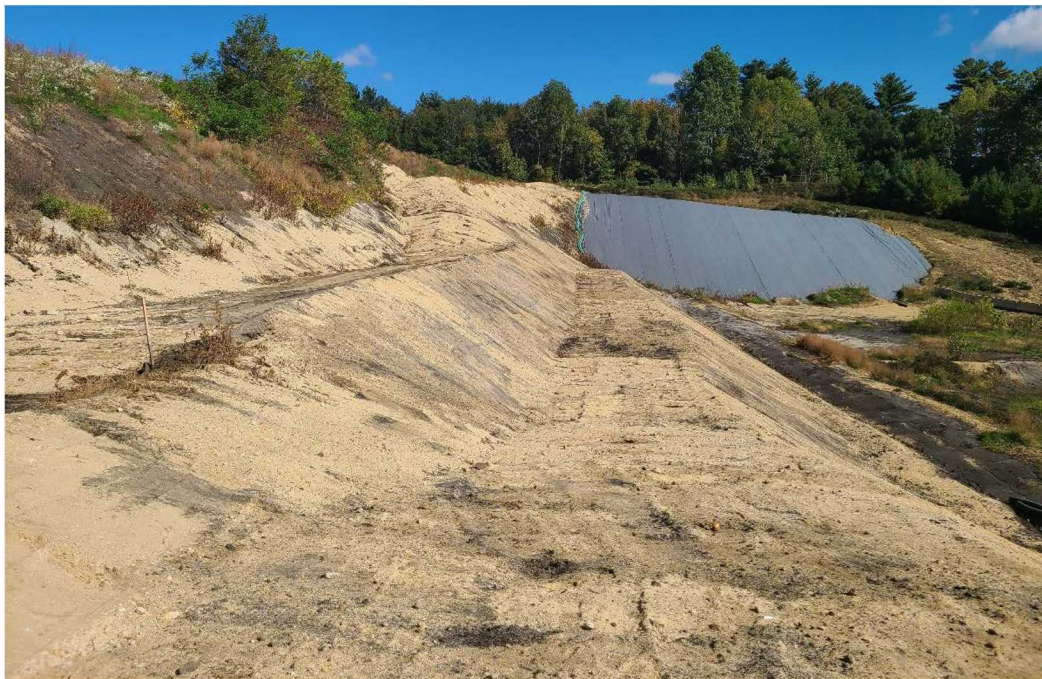
Photo 2: Active cell of the landfill with reduced steep slope at working face looking east from east side of active cell.

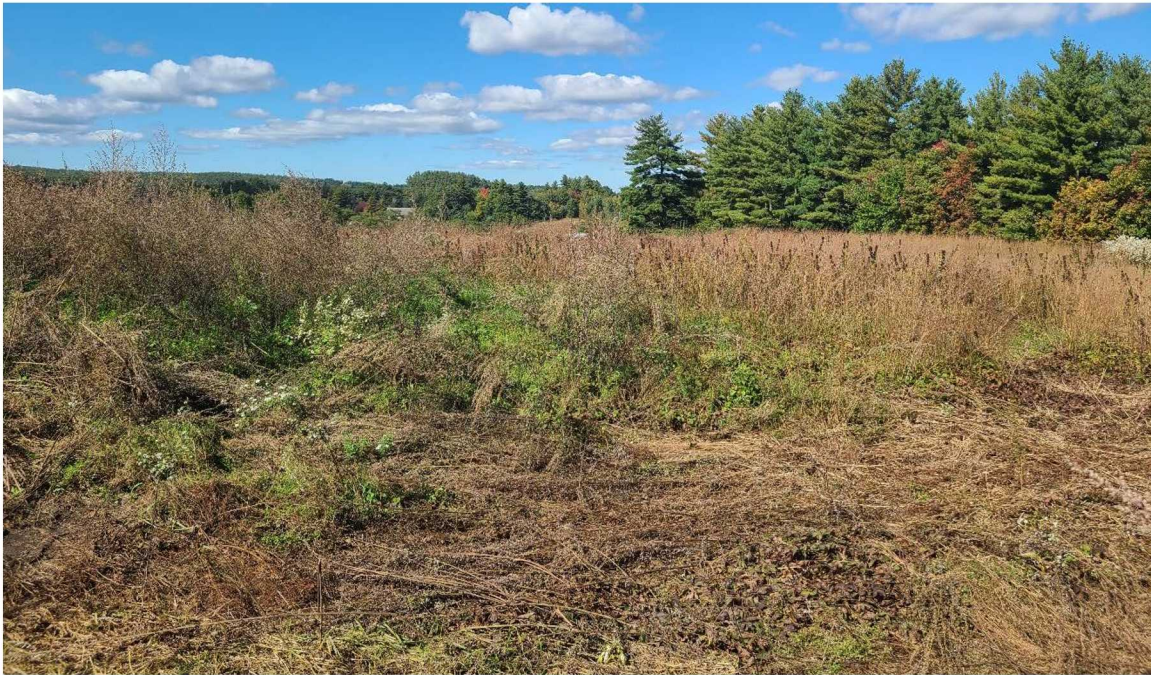
Photo 3: Stable and established slopes in inactive capped area of landfill looking north from top of filled area.

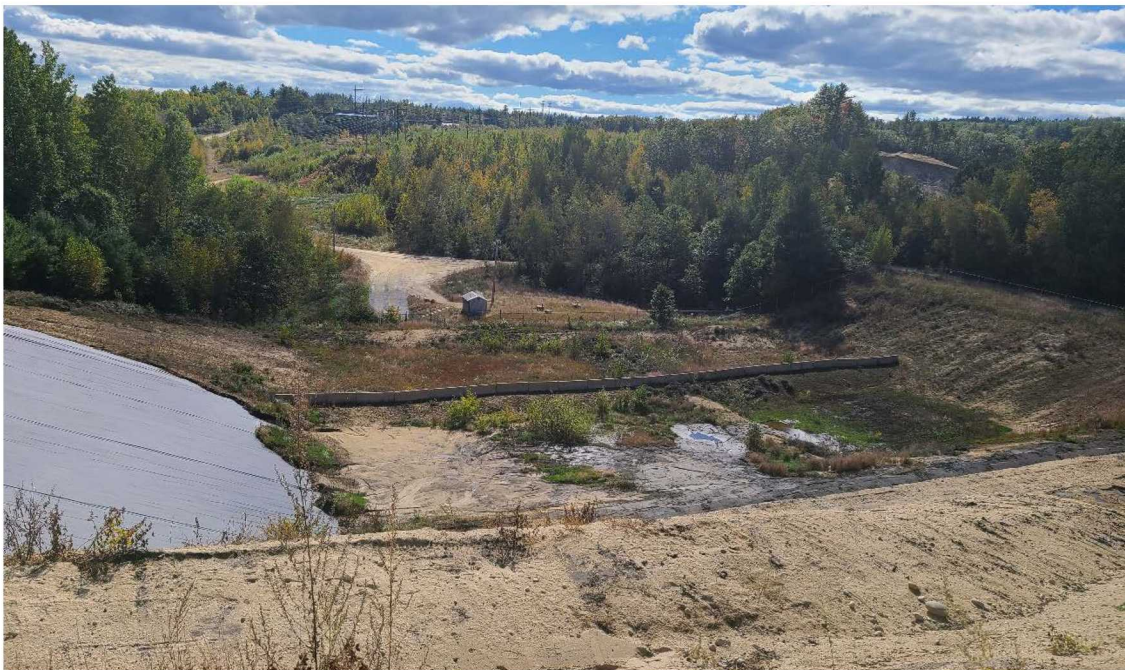
Photo 4: Landfill cells not currently in use looking southwest from active cell.
