Annual Inspection Report		Page No. 1 of 1	
<i>Inspection and report meeting the requirements of Part 257.84(b)</i>			
Merrimack Station Ash Landfill	Location: Bow, New Hampshire	Year: 2022	File No. 2025.13
Date of Inspection:	October 31, 2022	Volume of CCR in place: 210,500 cubic yards	
Completed by:	Harrison R. Roakes, PE		
Changes in landfill geometry since previous annual inspection? Yes <input type="checkbox"/> No <input checked="" type="checkbox"/> <i>If yes, please explain below.</i>			
Observed actual/ potential structural weakness? Yes <input type="checkbox"/> No <input checked="" type="checkbox"/> <i>If yes, please explain below.</i>			
Observed existing conditions that are disrupting/could disrupt the operation and safety of the facility? Yes <input type="checkbox"/> No <input checked="" type="checkbox"/> <i>If yes, please explain below.</i>			
Other Observations:			
<ul style="list-style-type: none"> • The steep slope observed at the active face of the landfill in previous years appears to be addressed by constructing a flatter benched slope using CCR material. As noted in Sanborn Head's Interim Slope Stability Evaluation, dated 2/29/2016, the existing steep is likely st

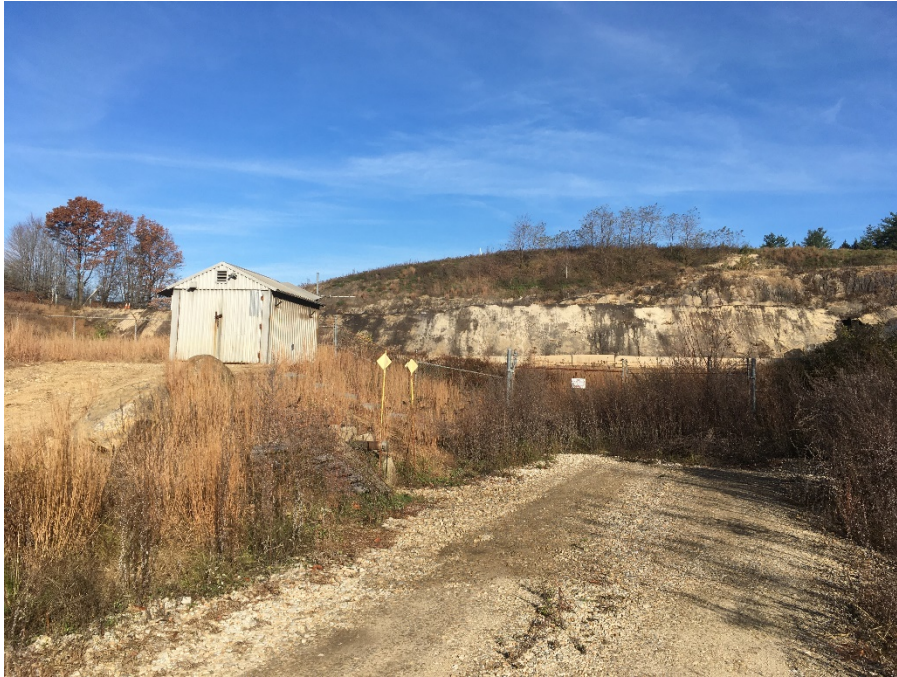
Photo 1: Landfill working face in the background and leachate collection building in foreground. The photograph was taken looking north.

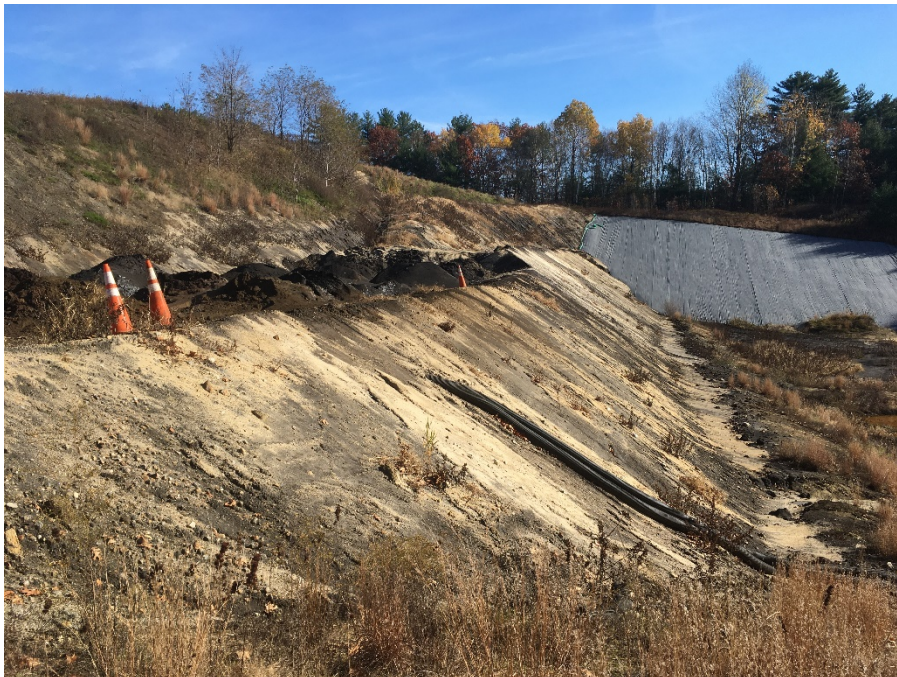
Photo 2: Landfill working face with flatter benched slope constructed. The photograph was taken from near the west side of the active area and looking east.

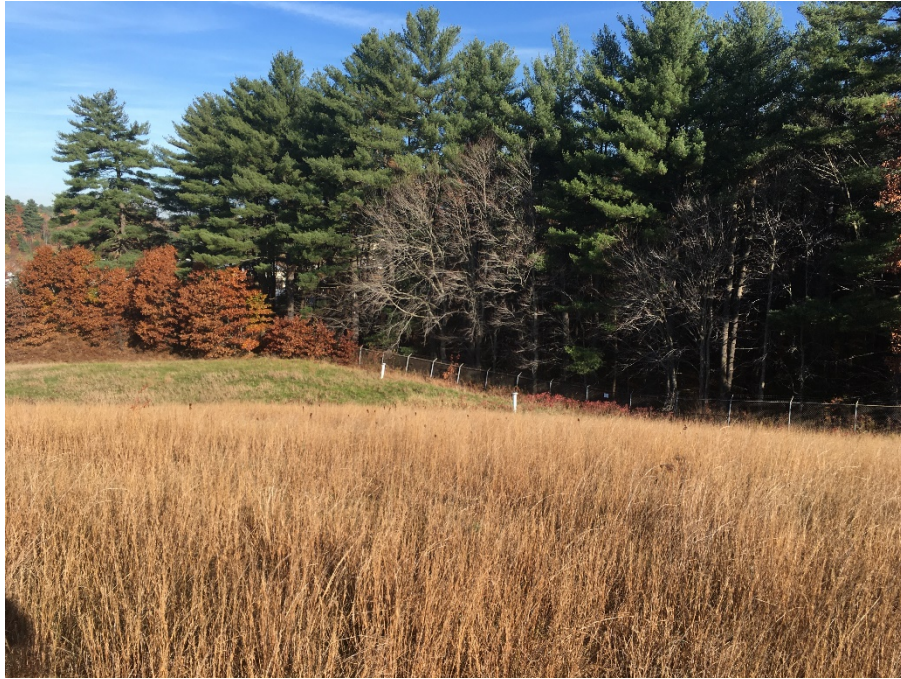
Photo 3: Stable and established slopes in inactive, capped area of landfill. The photograph was taken from near the top of the filled area and looking north.

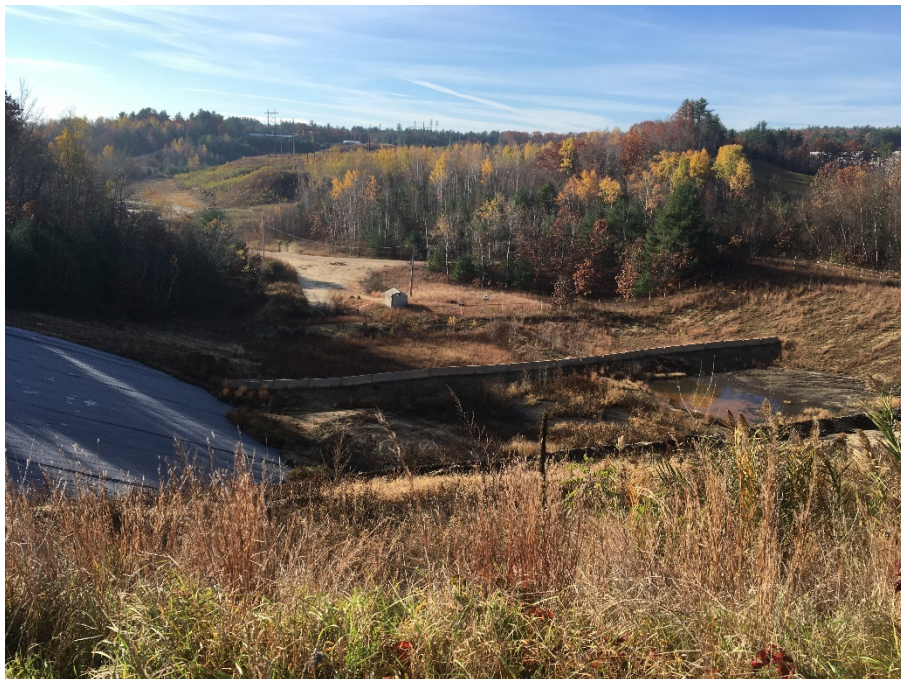
Photo 4: Landfill area not currently being filled. The photograph was taken from near the top of the active cell and looking southwest.
