Annual Inspection Report		Page No. 1 of 1	
<i>Inspection and report meeting the requirements of Part 257.84(b)</i>			
Merrimack Station Ash Landfill	Location: Bow, New Hampshire	Year: 2023	File No. 2025.14
Date of Inspection:	October 13, 2023	Volume of CCR in place: 211,300 cubic yards	
Completed by:	Harrison R. Roakes, PE		
Changes in landfill geometry since previous annual inspection? Yes <input type="checkbox"/> No <input checked="" type="checkbox"/> <i>If yes, please explain below.</i>			
Observed actual/ potential structural weakness? Yes <input type="checkbox"/> No <input checked="" type="checkbox"/> <i>If yes, please explain below.</i>			
Observed existing conditions that are disrupting/could disrupt the operation and safety of the facility? Yes <input type="checkbox"/> No <input checked="" type="checkbox"/> <i>If yes, please explain below.</i>			
Other Observations:			
<ul style="list-style-type: none"> • Material was added to the active face of the landfill by constructing benches. There was some erosion of benched materials on the active face, and the eroded material washed into the existing lined cell that includes leachate collection. Placement of additional material sh

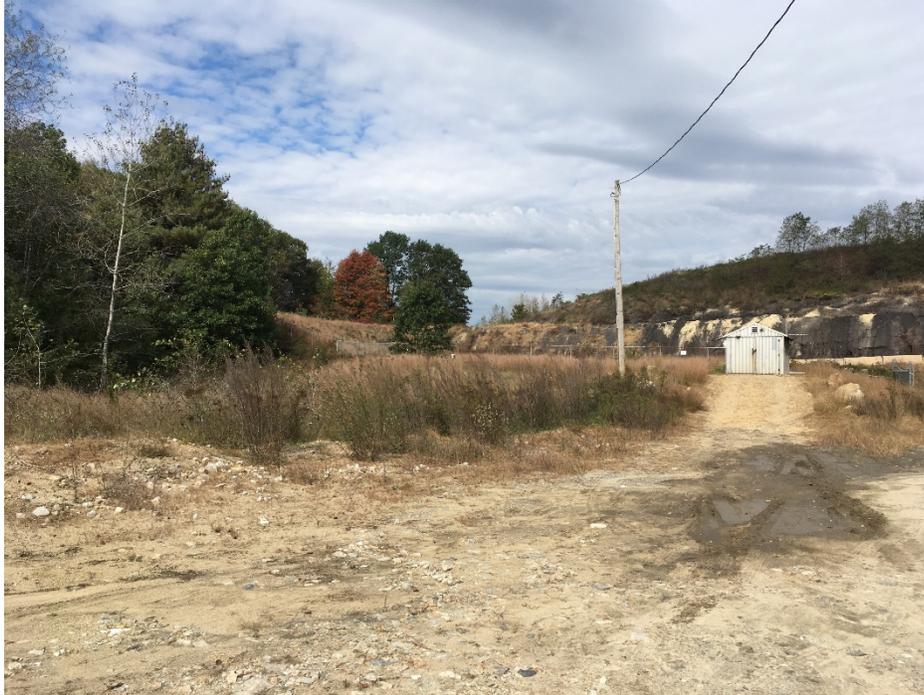
Photo 1: Landfill working face in the background and leachate collection building in foreground. The photograph was taken looking north.

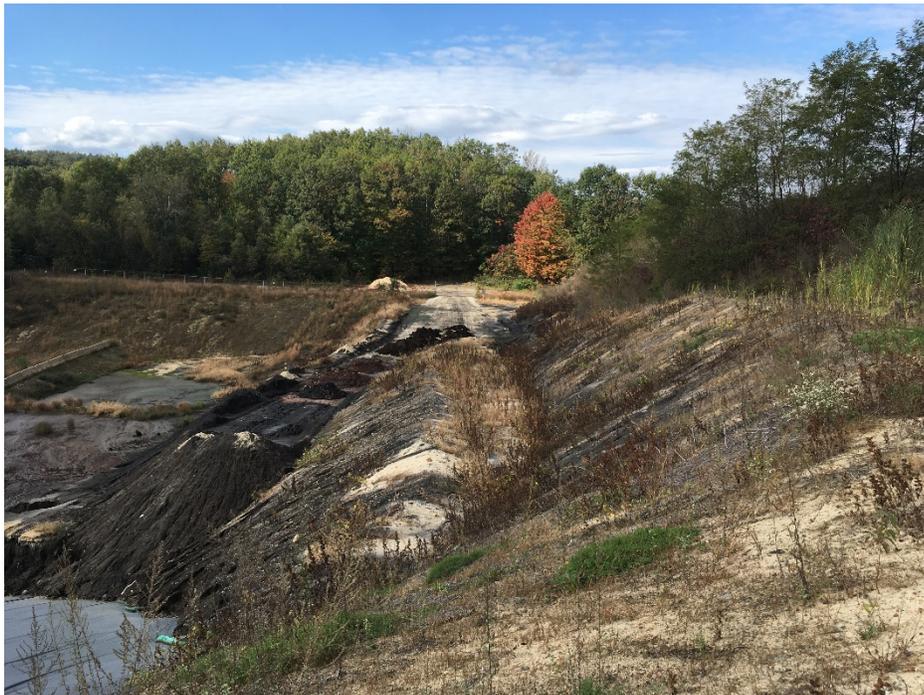
Photo 2: Landfill working face with benched slope constructed. The photograph was taken from near the top of the active cell and looking west.

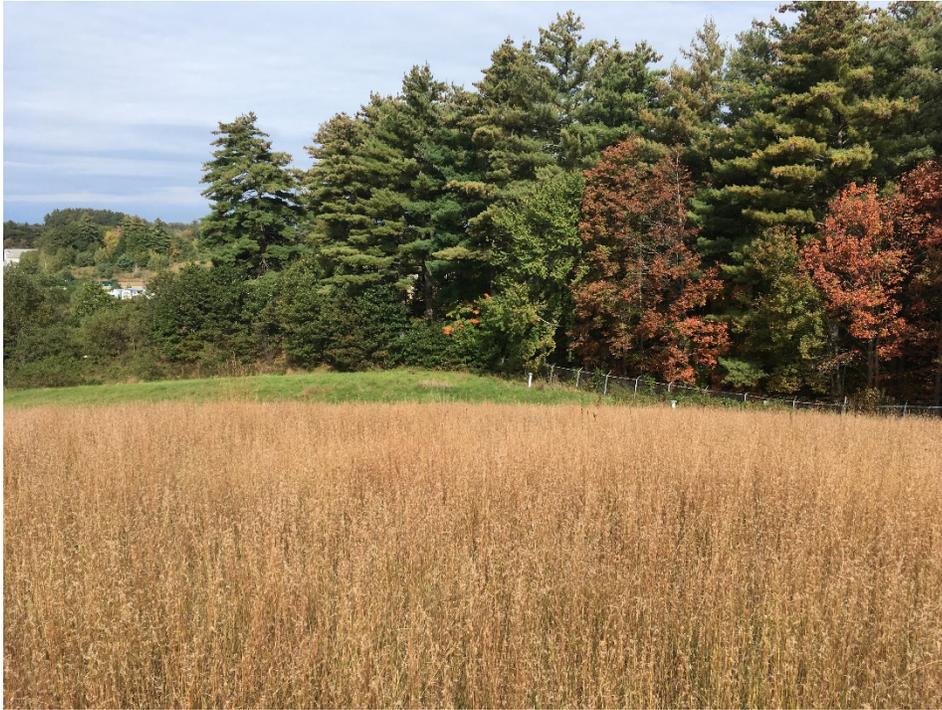
Photo 3: Stable and established slopes in inactive, capped area of landfill. The photograph was taken from near the top of the filled area and looking north.

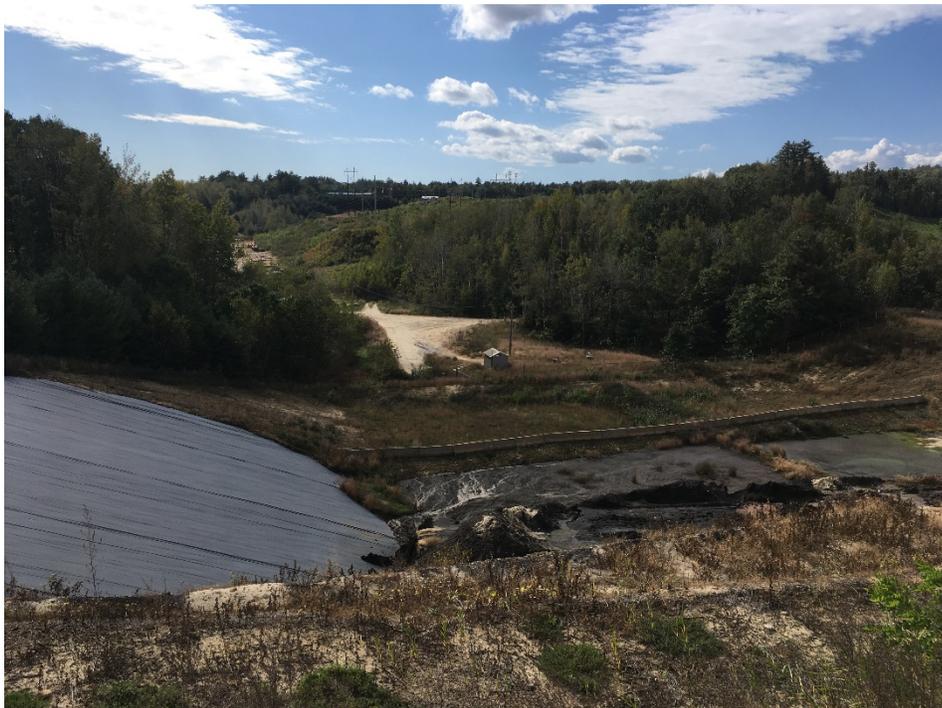
Photo 4: Landfill area not currently being filled (grassy area between leachate collection building and concrete barriers). The liner is visible on the left side of the photograph. The photograph was taken from near the top of the active cell and looking southwest.
