Annual Inspection Report		Page No. 1 of 1	
<i>Inspection and report meeting the requirements of Part 257.84(b)</i>			
Merrimack Station Ash Landfill	Location: Bow, New Hampshire	Year: 2020	File No. 2025.11
Date of Inspection:	October 15, 2020	Volume of CCR in place: 208,000 cubic yards	
Completed by:	Lisa Damiano, PE		
Changes in landfill geometry since previous annual inspection? Yes <input type="checkbox"/> No <input checked="" type="checkbox"/> <i>If yes, please explain below.</i>			
Observed actual/ potential structural weakness? Yes <input type="checkbox"/> No <input checked="" type="checkbox"/> <i>If yes, please explain below.</i>			
Observed existing conditions that are disrupting/could disrupt the operation and safety of the facility? Yes <input type="checkbox"/> No <input checked="" type="checkbox"/> <i>If yes, please explain below.</i>			
Other Observations:			
<ul style="list-style-type: none"> • Steep slope observed at the active face of the landfill. If the slope failed, CCR would slide into existing empty lined cell. We recommend reducing the slope for safety of operators. • The leachate collection and storage system was observed to be in good operating condition. • P

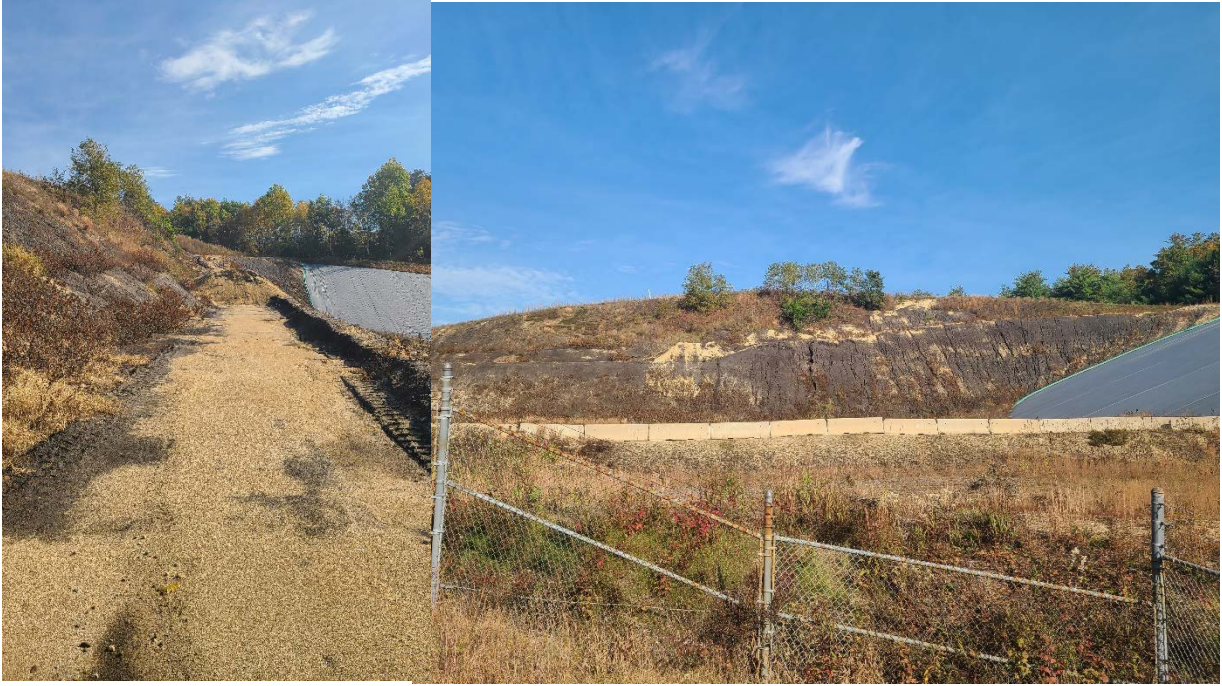
Photo 1: Active cell of the landfill with steep slope at working face looking north (right photo) from leachate collection building and east from east side of active cell (left photo)

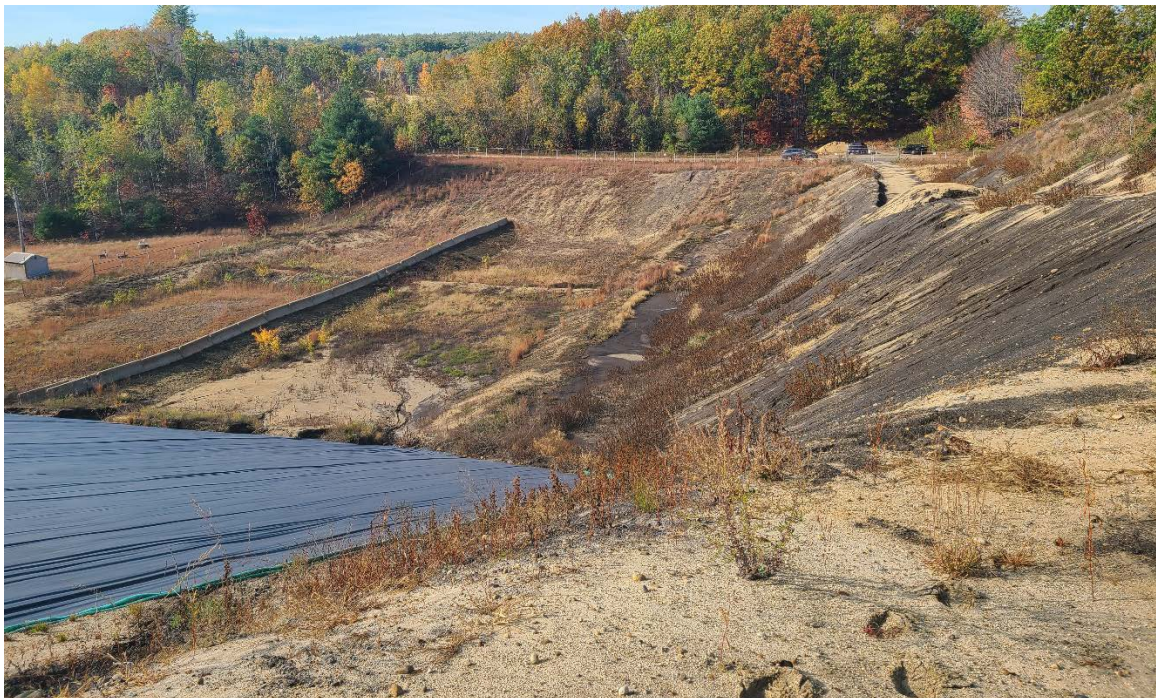
Photo 2: Active cell of the landfill with steep slope at working face looking west.

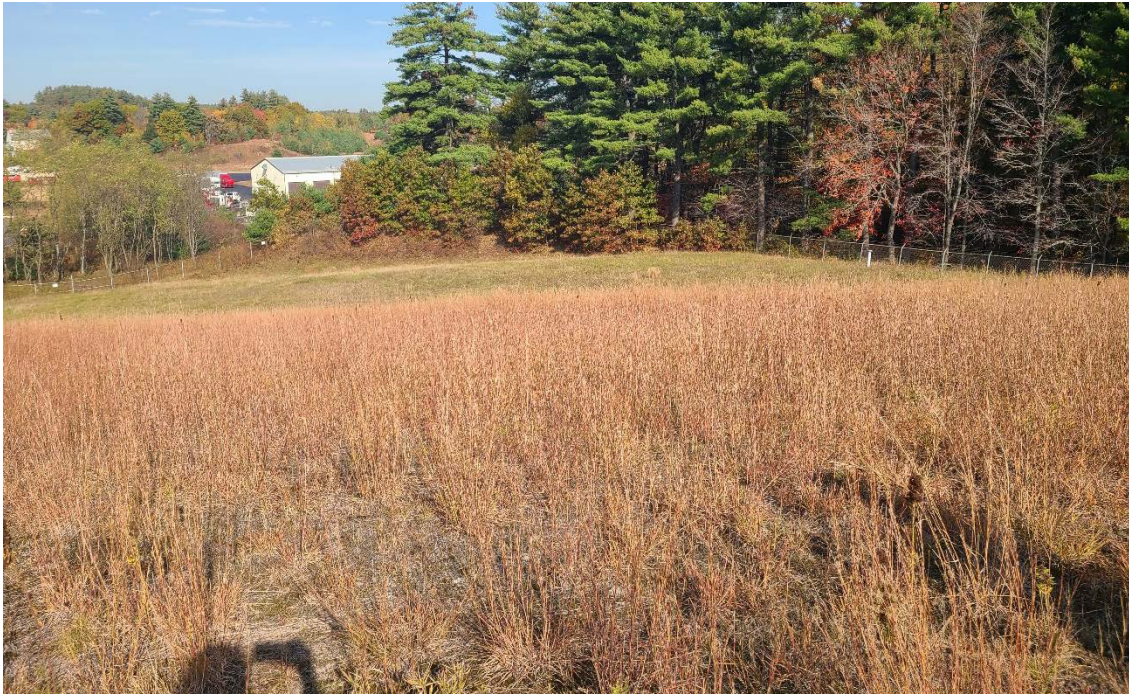
Photo 3: Stable and established slopes in inactive capped area of landfill looking north from top of filled area.

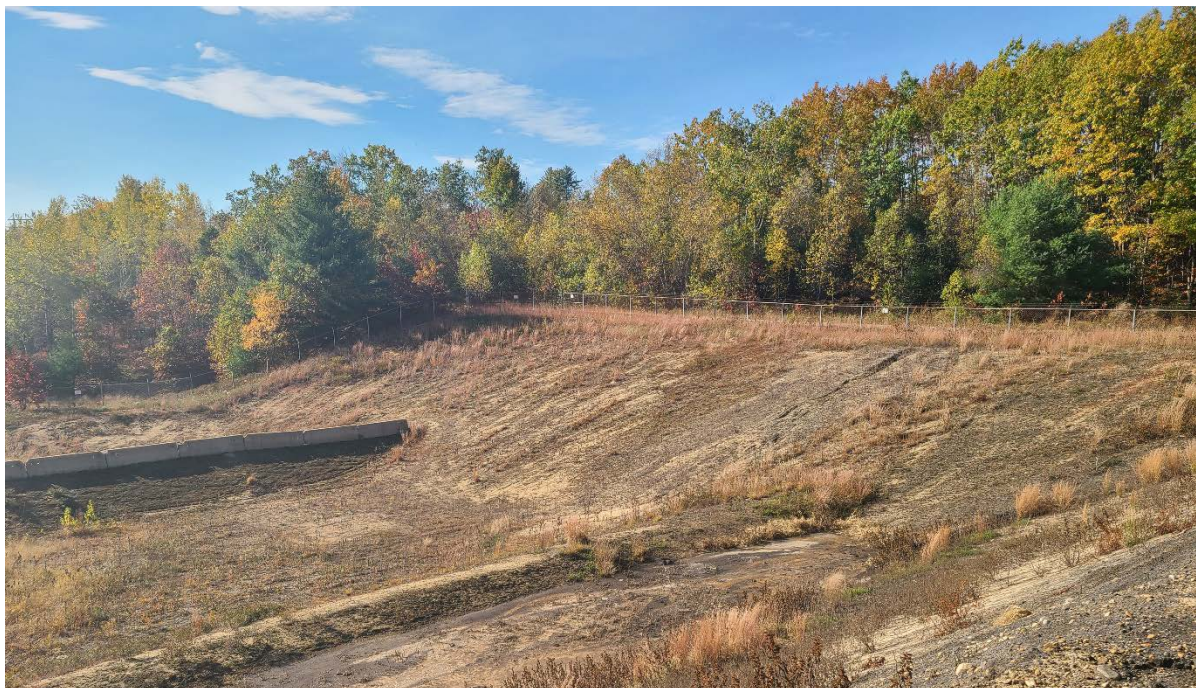
Photo 4: Landfill cells not currently in use looking southwest from southeast side of active cell.
